# REVERSING FORKLIFT VS PEDESTRIAN

## Summary

A customer at a retail distribution centre had her leg amputated when she was struck by a reversing forklift which had just delivered a dishwasher and dryer.

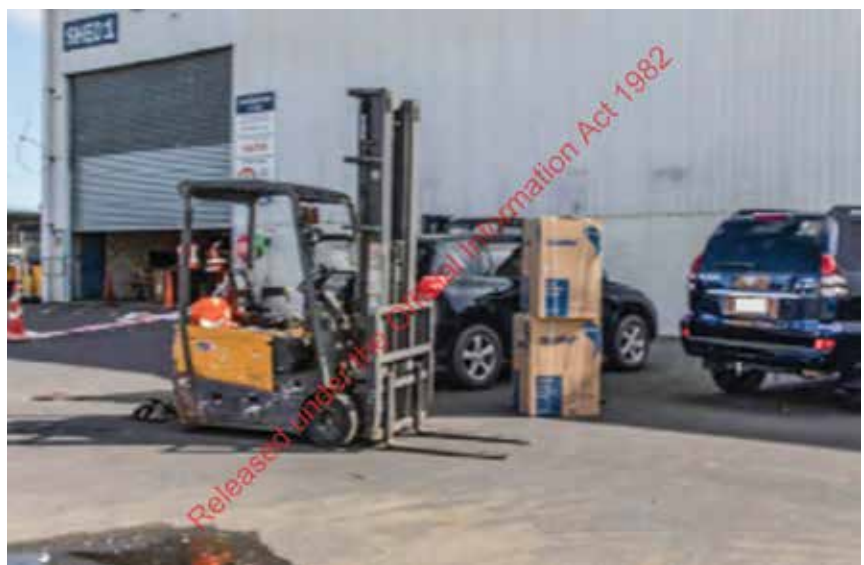
- Two customer vehicles arrived and parked in the collections area.
- One vehicle contained a married couple, the other their son-in-law.
- They went into the retail area and purchased a dishwasher and a dryer.
- The two men waited beside one car for the items to be delivered; the woman waited inside one of the cars.
- A forklift emerged carrying the items and drove to the back of the vehicle beside the two men.
- The forklift driver deposited the items on the ground and reversed the machine.
- At the same time the woman got out of the other car to take a photo of the items.
- She was struck by the reversing forklift.
- She was taken to hospital where her left leg was amputated below the knee.
- She also suffered degloving of her left thigh, lacerations, and a thumb fracture.

- The forklift's beacon light was not as visible as it should have been because the frame was broken so it was mounted below the roof line.
- Other lights on the forklift were not working at the time. The reversing beeper was working.
- There was no traffic management plan.
- The hazard register identified forklifts as a hazard but not that these hazards operated in the customer collection area.
- The register identified the control as a no-go zone, but there was no such zone.
- CCTV footage from the previous few weeks showed forklifts moving in and around pedestrians on a daily basis.
- The site held weekly toolbox meetings but there was no evidence that pedestrian/ forklift interaction was ever discussed.
- The company had inherited the site from a previous occupant. Redundant traffic management devices were left in place

- Forklifts and other mobile plant require a rigorous maintenance schedule and daily checks that all safety devices are operating.
- Pedestrians should never be put in a position where they might encounter mobile plant.
- Exclusion zones and physical barriers should be used to ensure this is the case.
- Site design can include separate entrances and exits for vehicles and pedestrians.
- The need for mobile plant to reverse can be designed out.
- WorkSafe's document *Managing Work Site Traffic* was published in February 2021.
